- RGC REPORT NO 111001/7

DAM INSPECTION – December 2007

• TAILINGS DAM REVIEW BOARD REPORT NO 7

• MARLIN PROJECT, GUATEMALA

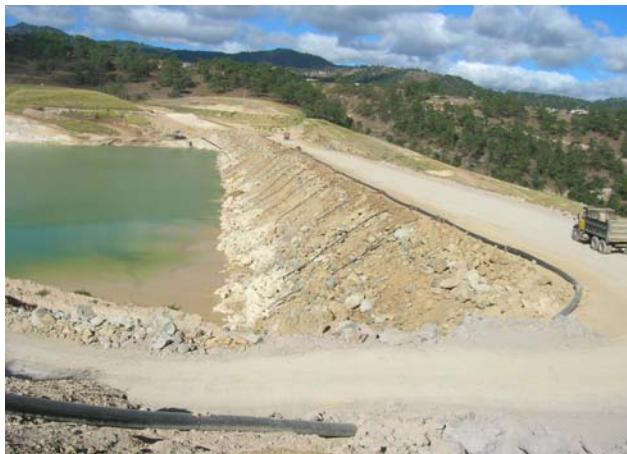
Upstream face with tailings spigot line

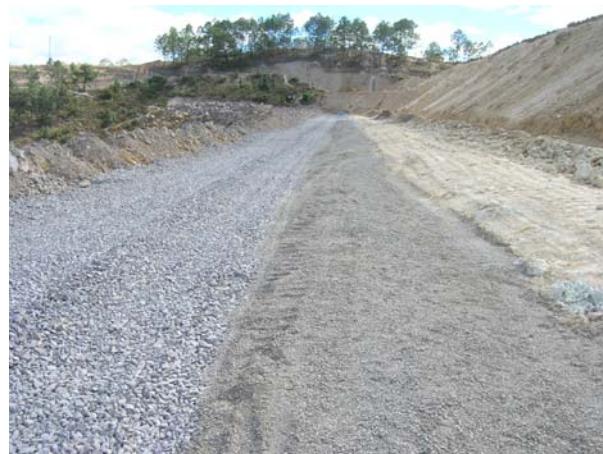
Downstream Phase 2B raise filter zones

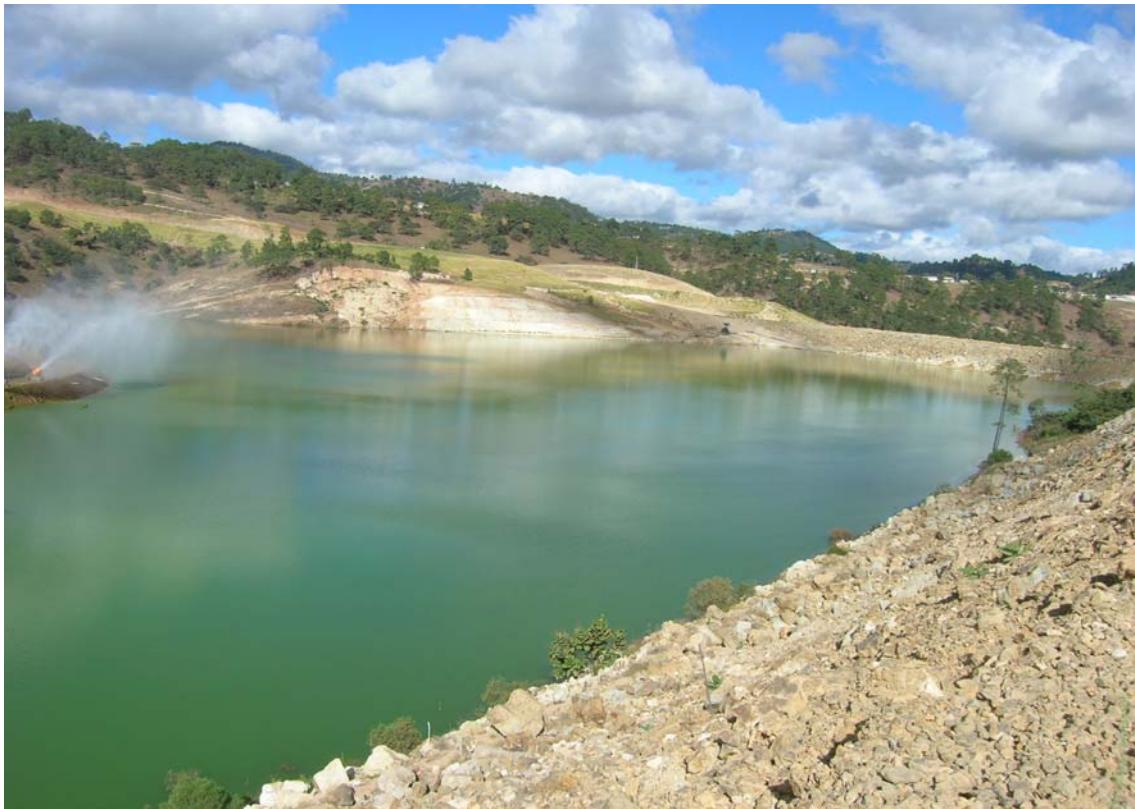
The tailings impoundment was reservoir was observed (Photo 1 – appendix A) and high algae content resulting from ammonia concentrations noted. Discharge of such water, without treatment for the ammonia, would result in algae blooms in the receiving stream and MEG is in the process of having water treatment facilities designed and installed in time to achieve water treatment when discharge will be required. Water evaporators were operating (Photo 1 and 2) to reduce water accumulation, such that discharge can be avoided until treatment facilities have been installed.

The intense algae bloom in the tailings pond was noted (Photo 1 to 4). *The potential for the discharge standard of 10 ppm Nitrates in discharge water being an issue for downstream stream appearance should be investigated.*

PHOTO 1 – Tailings impoundment from right flank. Embankment at right, mid-height.

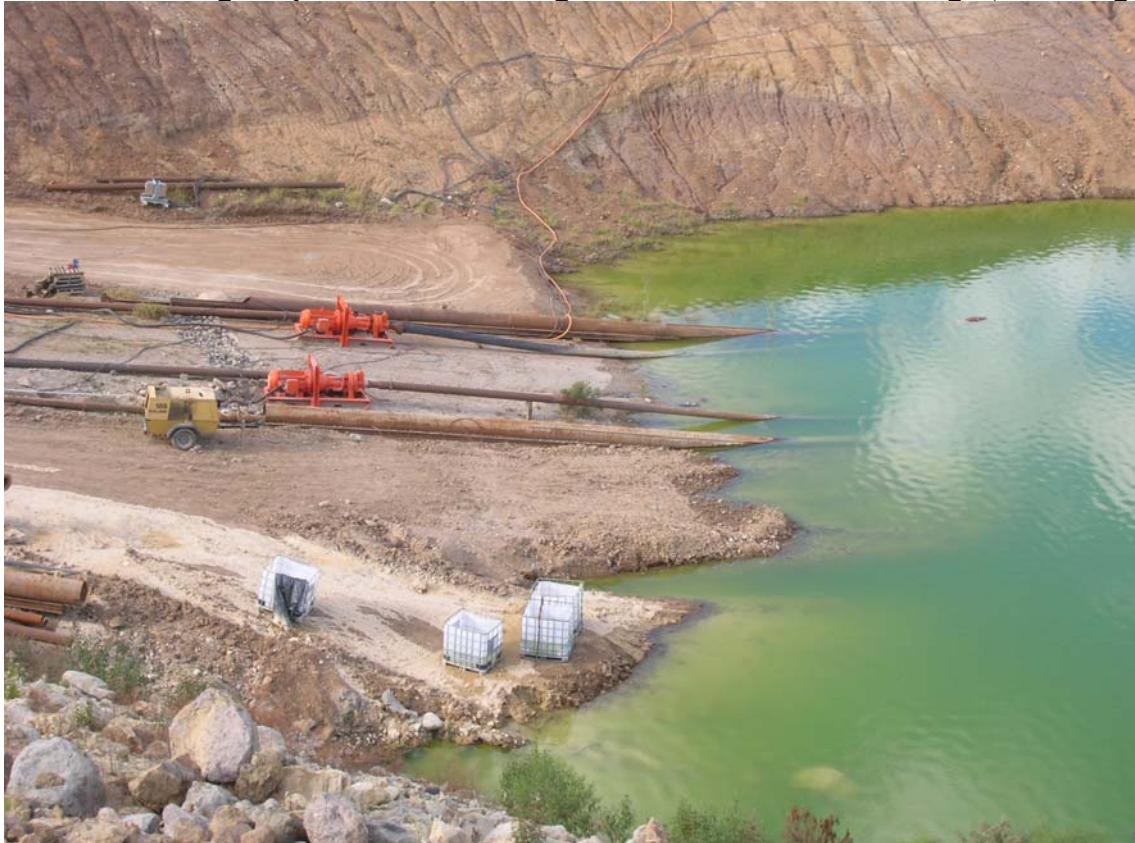
The existing water reclaim intakes and pumps were observed. These will be replaced with pumps mounted on a floating barge (Photo 18) and the barge relocated in the next inlet on the right flank of the impoundment further from the tailings embankment. This change of location allows for more effective tailings beech development against the upstream face of the embankment and reduces the need for sediment control and flocculent addition required at the current location.

PHOTO 2 – Current tailings water reclaim pumps and intakes

The proposed changes to the pond water reclaim system and location is appropriate (Photos 2 and 18). Consideration should be given to installing a skimming box around the pump intakes to allow return water to be skimmed from the top if the pond. New inlet OK, barge OK – consider decant box under pumps. Consider can also be given to cutting a trench up the center of the valley in which the barge is located allowing the barge to retreat up the trench as pond water level rises. This facilitates easy access to the barge and allows addition sediment control within the trench.

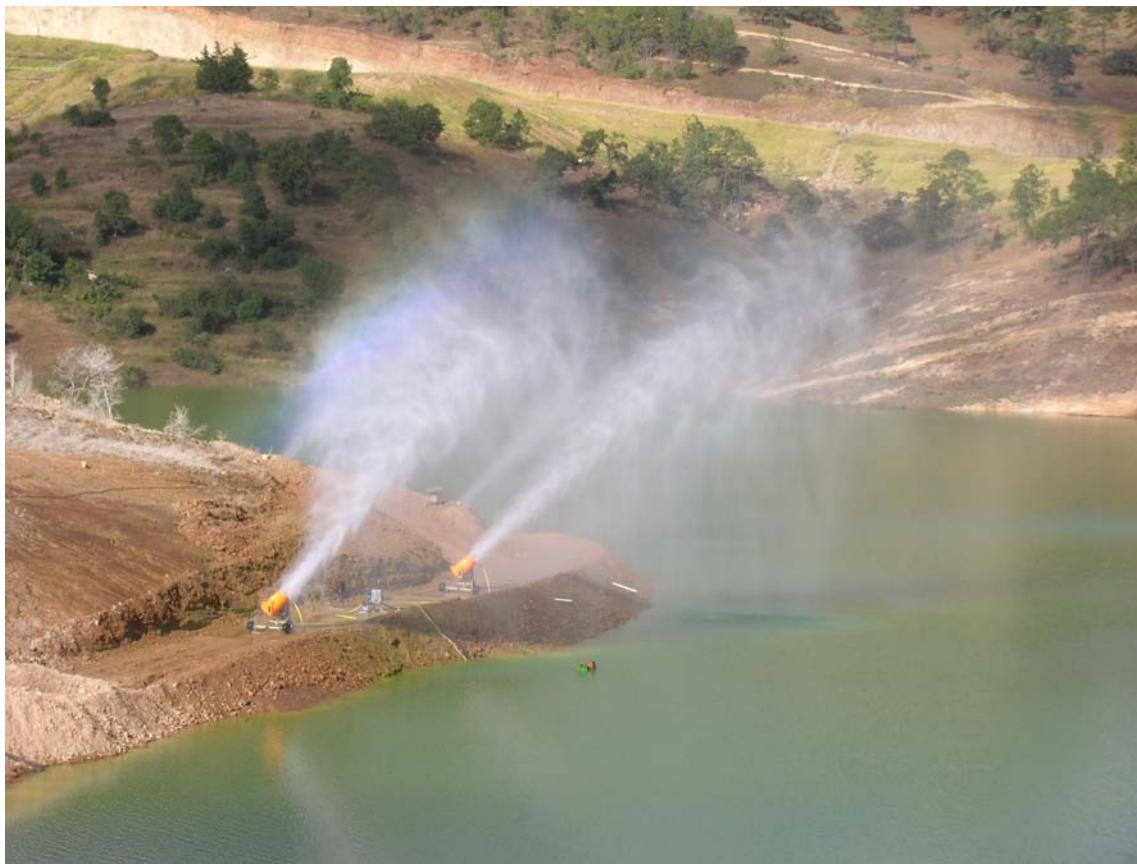
PHOTO 3 – Vaporizing tailings water to reduce water accumulation

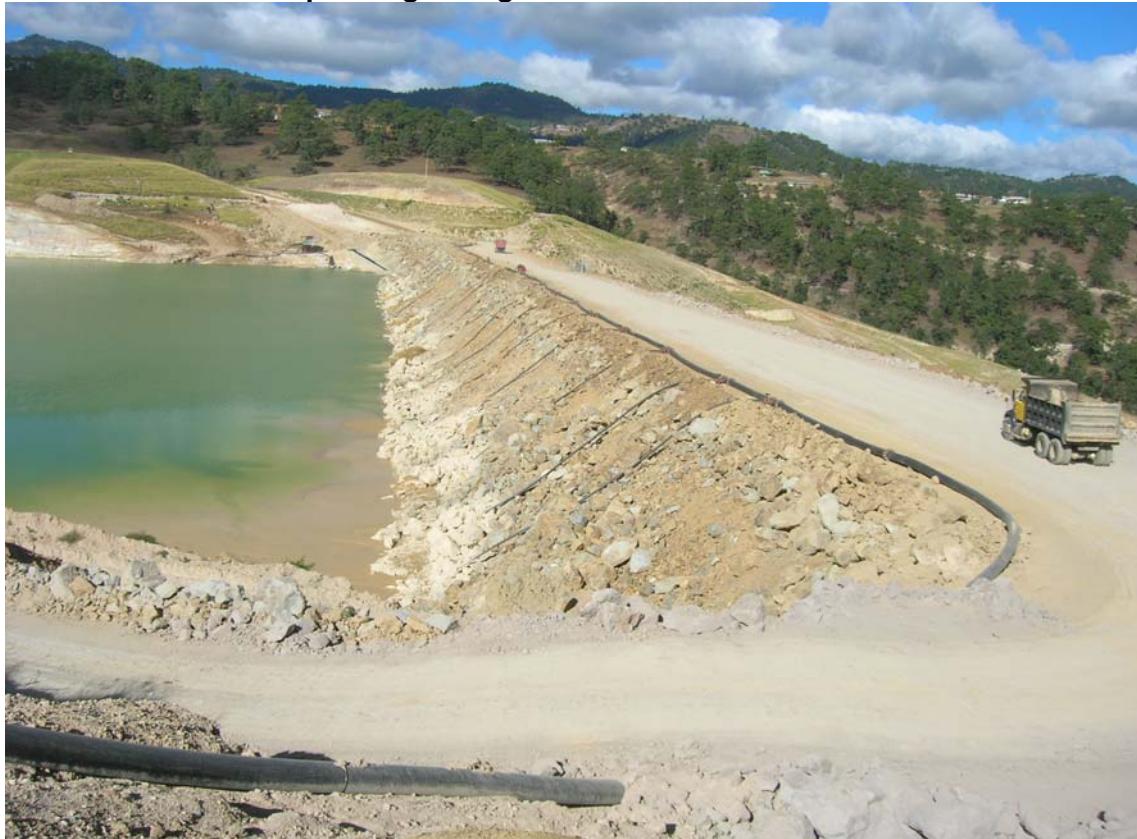
The crest of the dam at El 1948 was observed (Photo 4) with the installed tailings distribution line and spigots allowing uniform discharge along the entire face of the dam. The dam crest has been constructed to 2 m higher than originally scheduled to provide additional freeboard and storage. The absence of beach development was noted and this air drying is limited and this partly responsible for the low tailings densities being observed in the impoundment.

Stage 2A construction is complete (Photo 4) and Stage 2B is underway (Photos 8, 9, 10, 11). The writer has requested a copy of the Stage 2A as-built report, when available.

PHOTO 4 – Upstream crest (1948 m) of dam with tailings line and discharge spigots

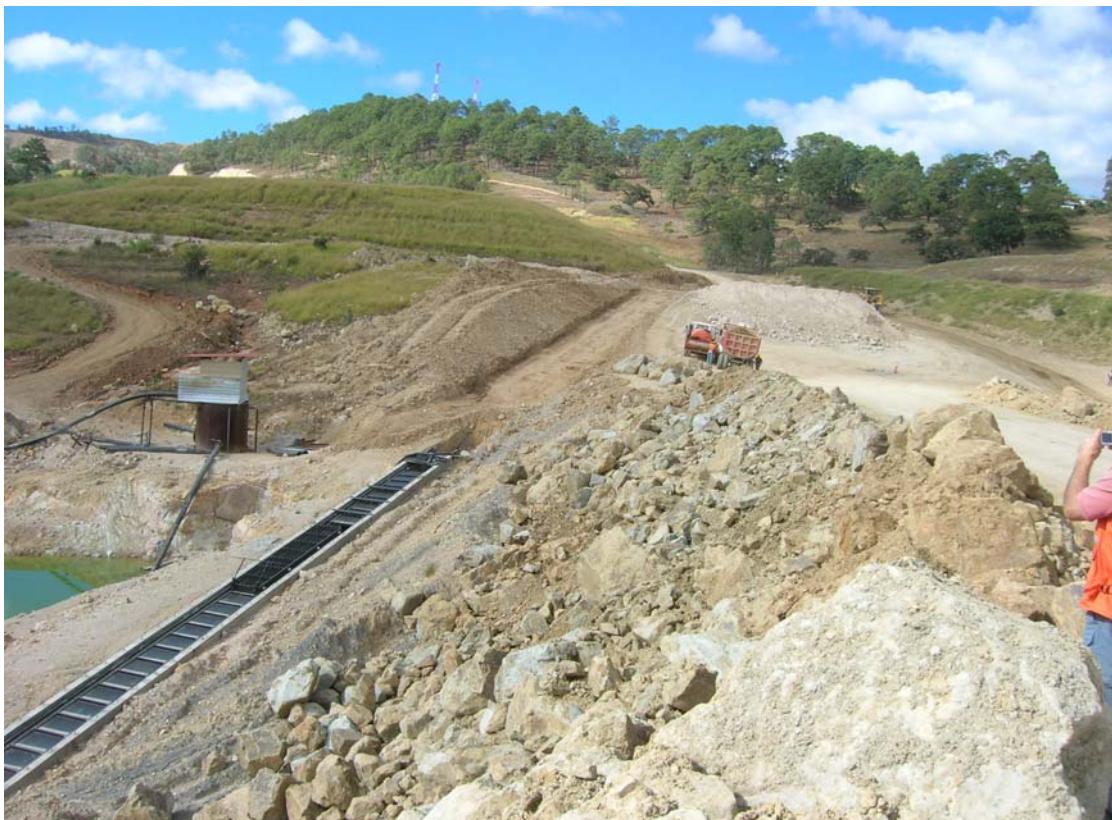
The decant intake was observed (Photo 5) with the stop-log sill set at 1939. The maximum elevation of sill that can be achieved with the current structure is 1942 and foundation preparation for extending the decant was observed. It was understood that this addition would be completed within 6 weeks to meet water storage capacity requirements and available as a result of the 2 m overbuild of the embankment.

The Dam embankment has been raised to by 2 m more than Stage 2A design (to EI 1948 by Nov 2007). Stage 2A decant sill (Photo 5) has a limit of 1942 and the extension needs to be constructed before advantage can be take of the 2 m of additional dam height. Stage 2B decant raise construction is scheduled to start January and be completed by April. *Timely completion is critical to having the additional 2 m capacity available for storage at onset of rains in 2008.*

PHOTO 5 – Left abutment with stop-log decant sill set at 1939 (max 1942) with foundation preparation for construction of extension. Adjacent test tank for water treatment testing

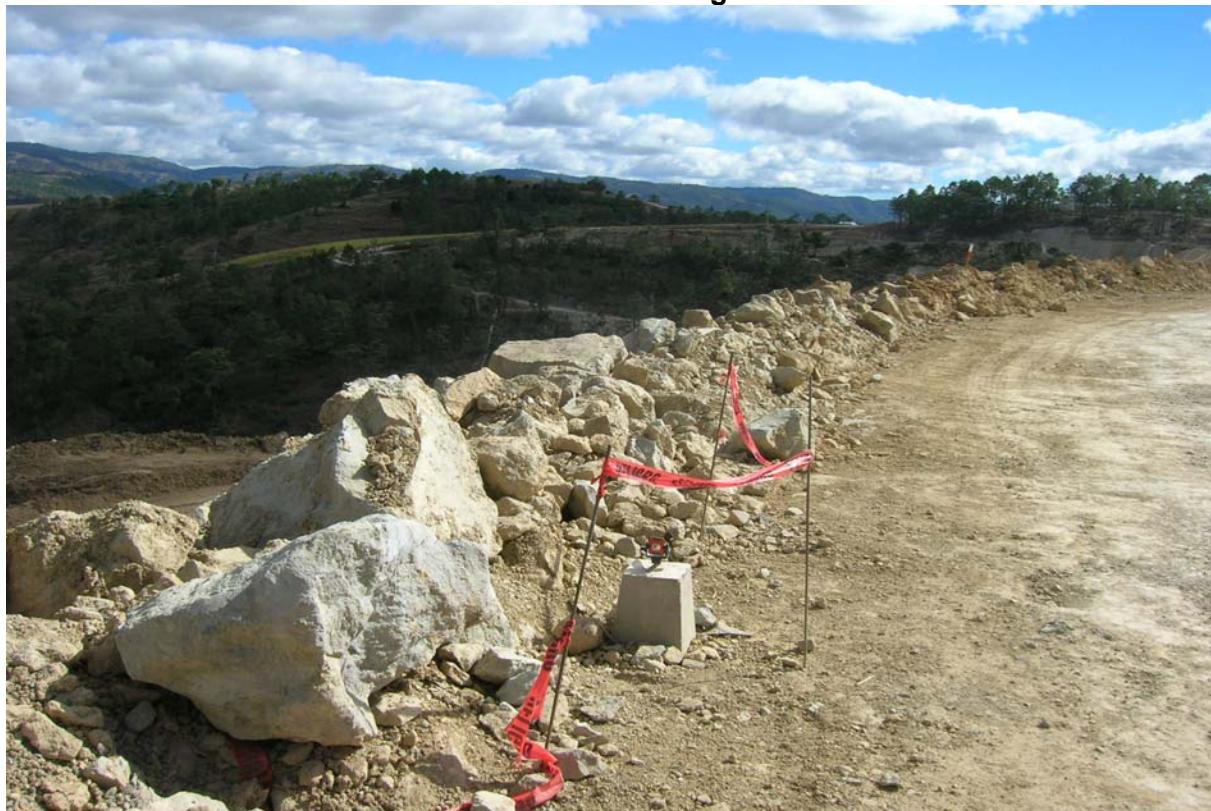
Instrumentation installation had been completed in the form of survey monuments (Photo 6) and a seismometer (Photo 7) on the dam crest. A second seismometer is installed at the instrument hut on the right abutment. Installation of the fibre optic cables to the vibrating wire piezometers installed in the embankment (Photo 11) was observed. All installation measures and methods are considered appropriate.

PHOTO 6 – Survey monument on dam crest

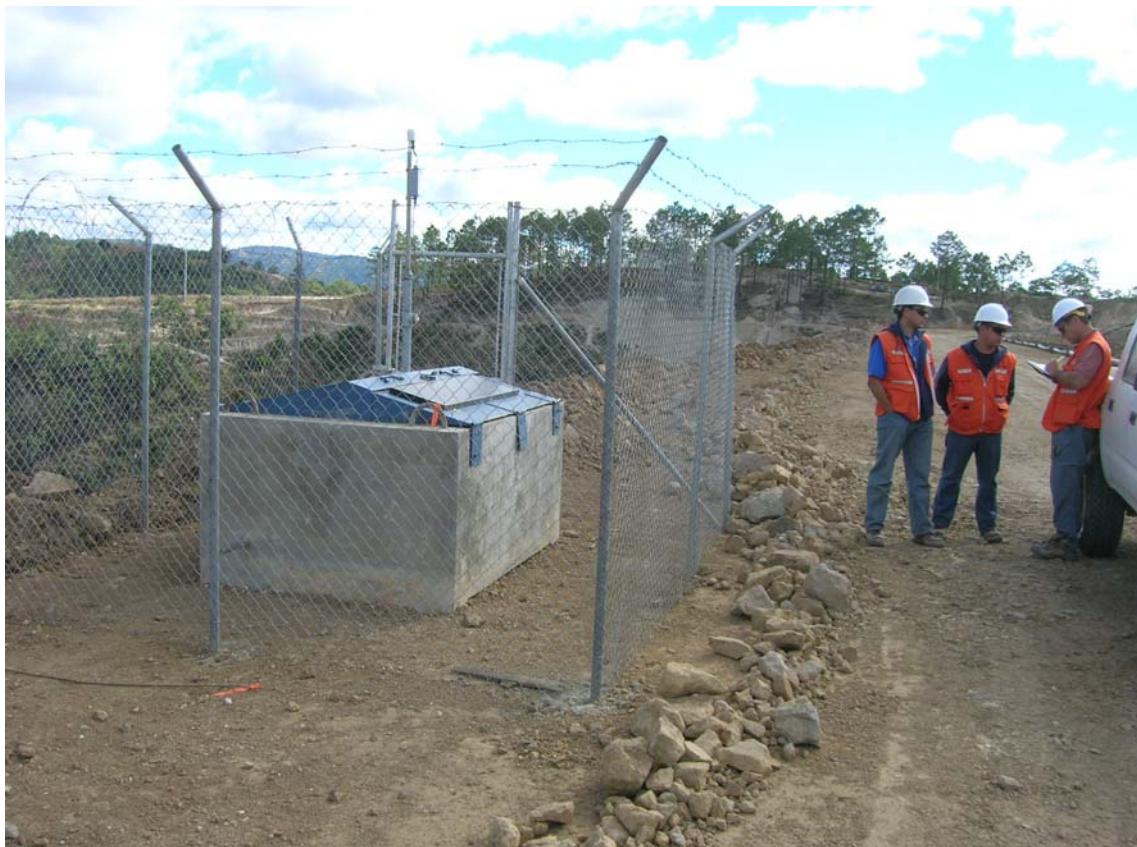
Photo 7 – Container housing seismometer on dam crest

The dam instrumentation indicates good performance, well within design limits. The most recent earthquake felt at the mine site did not trigger the seismometers. *A reset of the seismometers to record lower intensity events should be considered.*

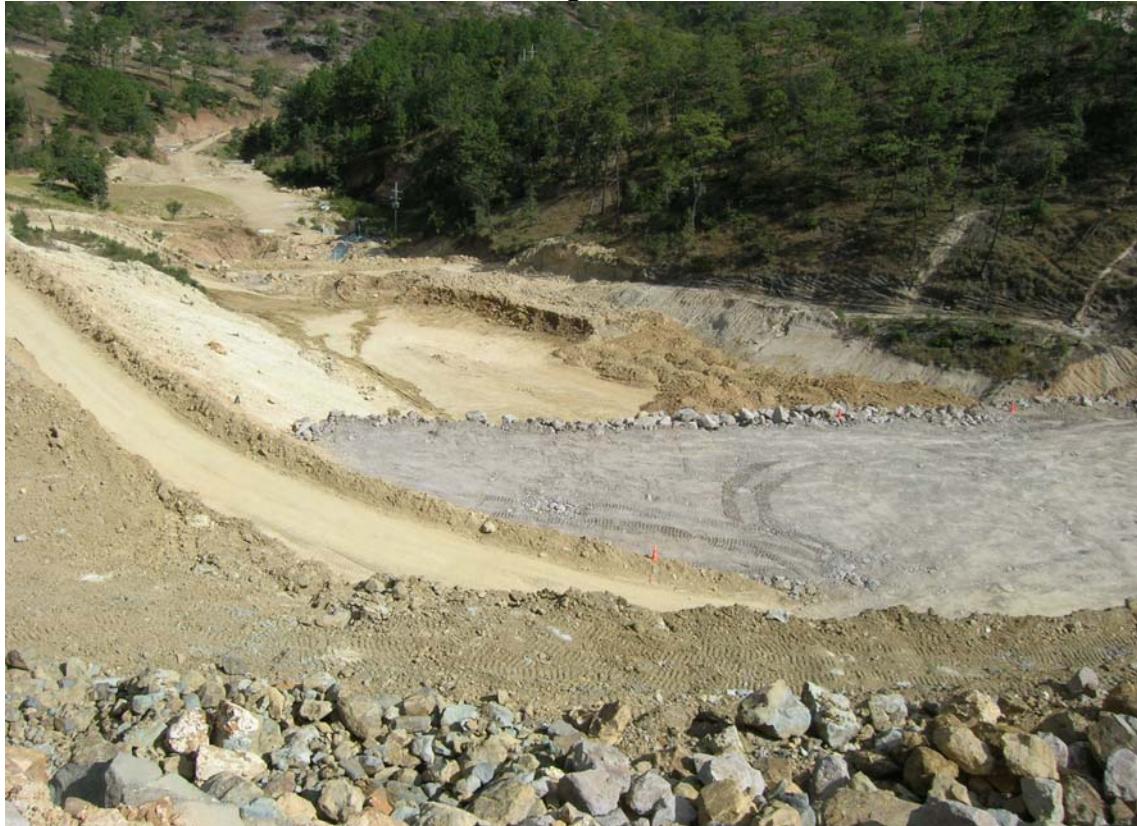
The downstream construction of the Phase 2B shell was inspected (Photos 8, 9 and 12) as well as exposed Phase 2A shell material under the boulder surface (Photo 13 &14). The high fines content of the Phase 2A shell rockfill was noted. This has been discussed in previous review reports, and tests have previously been completed by MEC to demonstrate that the higher fines fill has shear strength properties which meet design requirements. The nature of rockfill being placed during the inspection is seen in Photo 12 and comprised large boulders with sand fines. The sand fines were generally less than that seen in the photo. Some of the boulders exceeded the specification limits and these would be pushed off the layer and onto the dam backslope, as is seen in photo 13. *The amount of large boulders included in the fill being placed at the time of inspection was considered excessive and more selective loading, with exclusion of the boulders, is recommended at the quarry or mining site.* The transition zone material would not meet filter criteria against this coarse boulder rockfill. *Such coarse rockfill should only be placed well downstream from the transition layer.*

Photo 8 – Downstream toe showing Phase 2B raise rockfill (grey) over valley base under drain

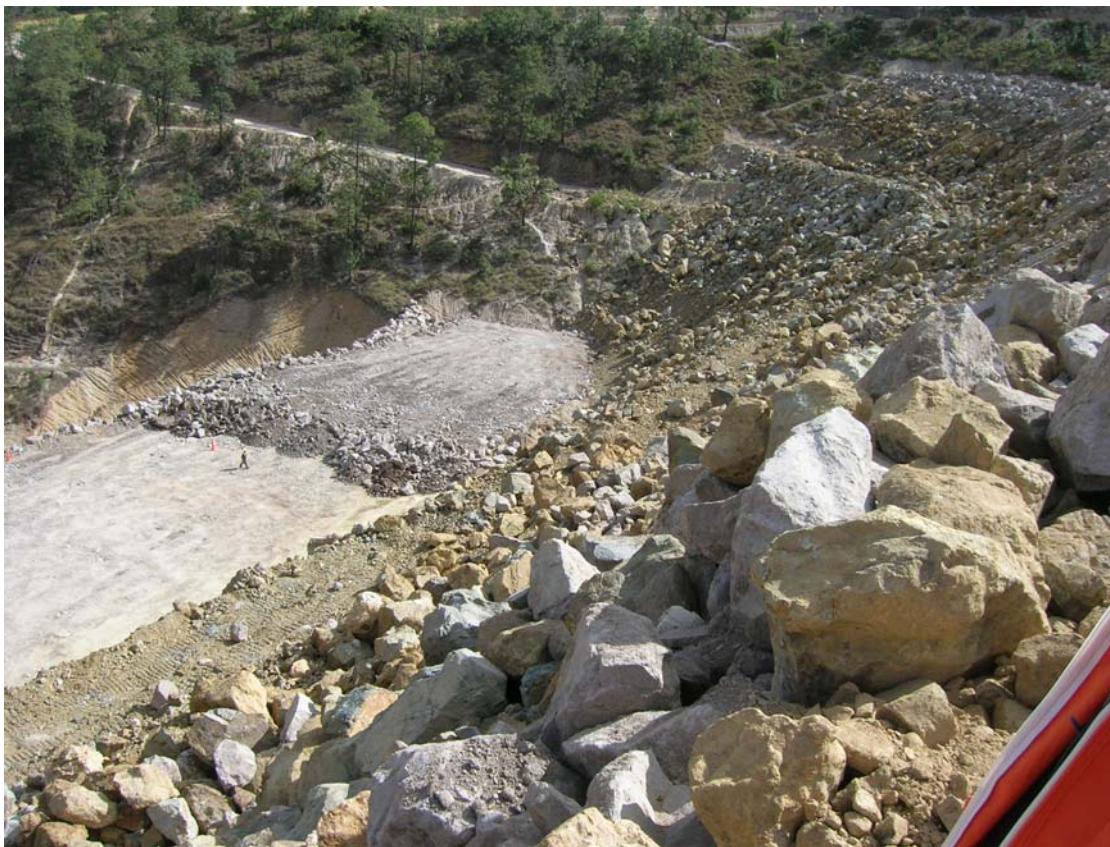
The boulders pushed onto the back slope of the dam pose a work hazard, particularly during wet weather (Photo 9 and 13). *Safe working practices should be developed and implemented.*

Photo 9 – Rockfill layer (grey) being placed on downstream shell zone

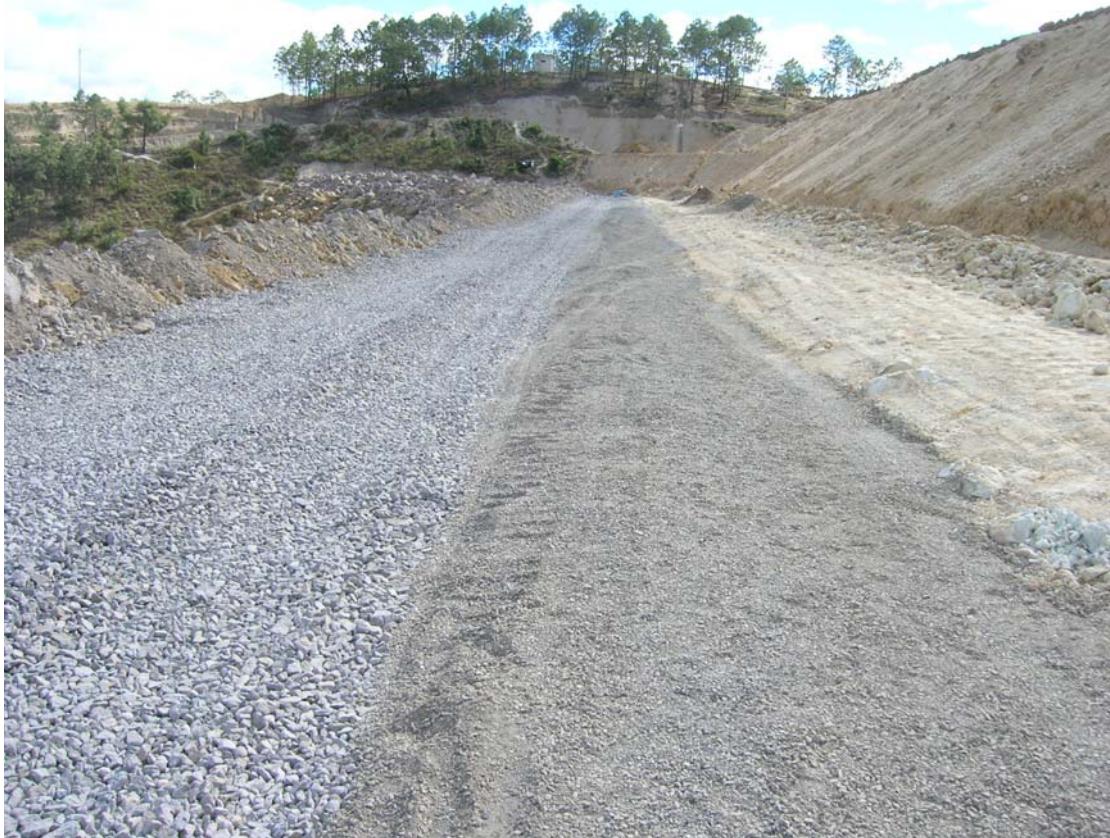
The Phase 2B core, filter and transition zones had been raised in advance of the shell zone material (Photo 10 and 11). Materials and placement methods were appropriate.

Photo 10 – Phase 2B core, fine filter and transition zone on bench ahead of d/s shell

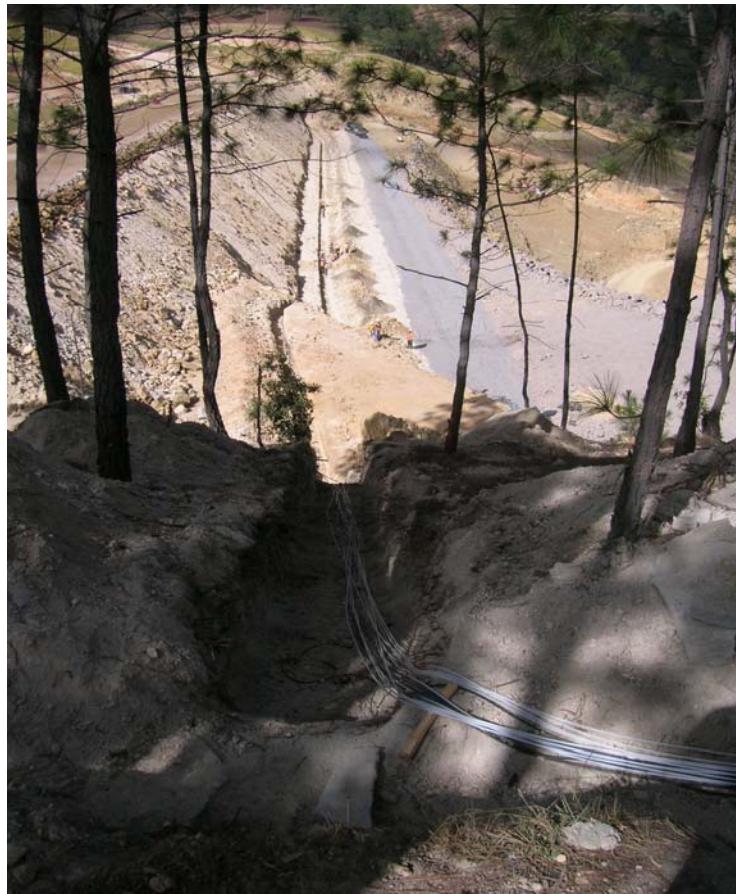
PHOTO 11 – Trench in core zone carrying optical cables from piezometers

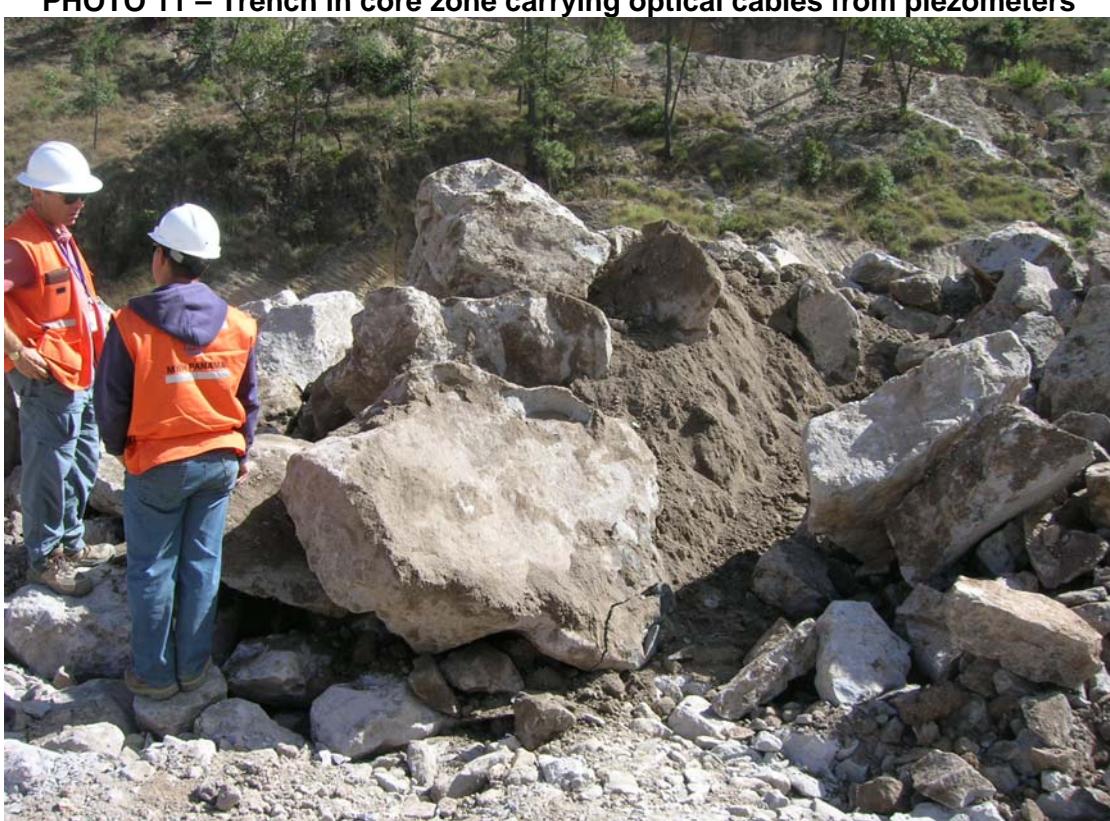
Some rock fill is very poorly graded, large boulders with sand (Photo 12). More selection at quarry recommended. Lifts appeared in excess of 1 m specified (Photo 12). *More care in fill layer thickness is needed.*

Photo 12 – Large boulders and sand fines in rockfill

- Fill placement observed. Some rock fill very poorly graded, large boulders with sand. More selection at quarry recommended. Lifts appeared in excess of 1 m specified. More care in fill layer thickness needed.

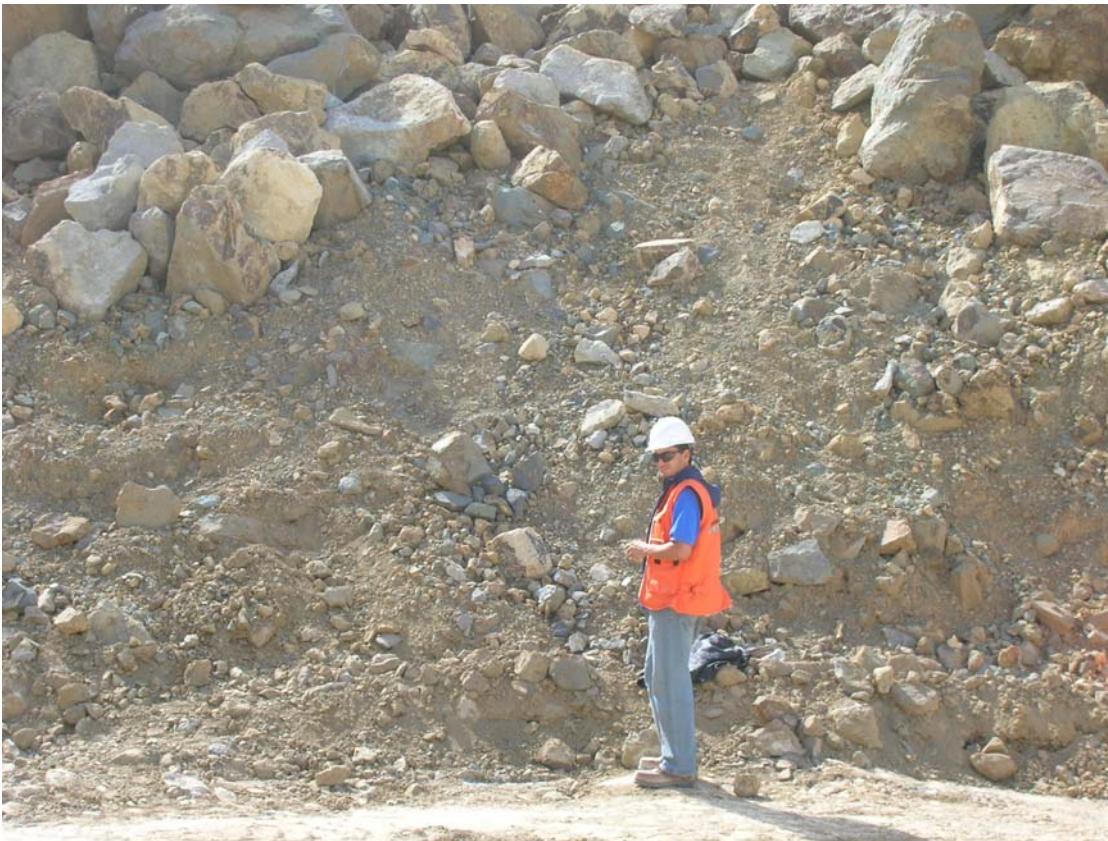
Rockfill for shell is still a critical material supply constraint. Field observations show some benches on 2A raise are essentially soil fill (Photo 13 and 14). Some Rockfill is being provided from special quarry. *It is essential that a high level of effort be maintained to achieve rockfill requirements.*

PHOTO 13 – Typical d/s shell fill after stripping of surface boulders

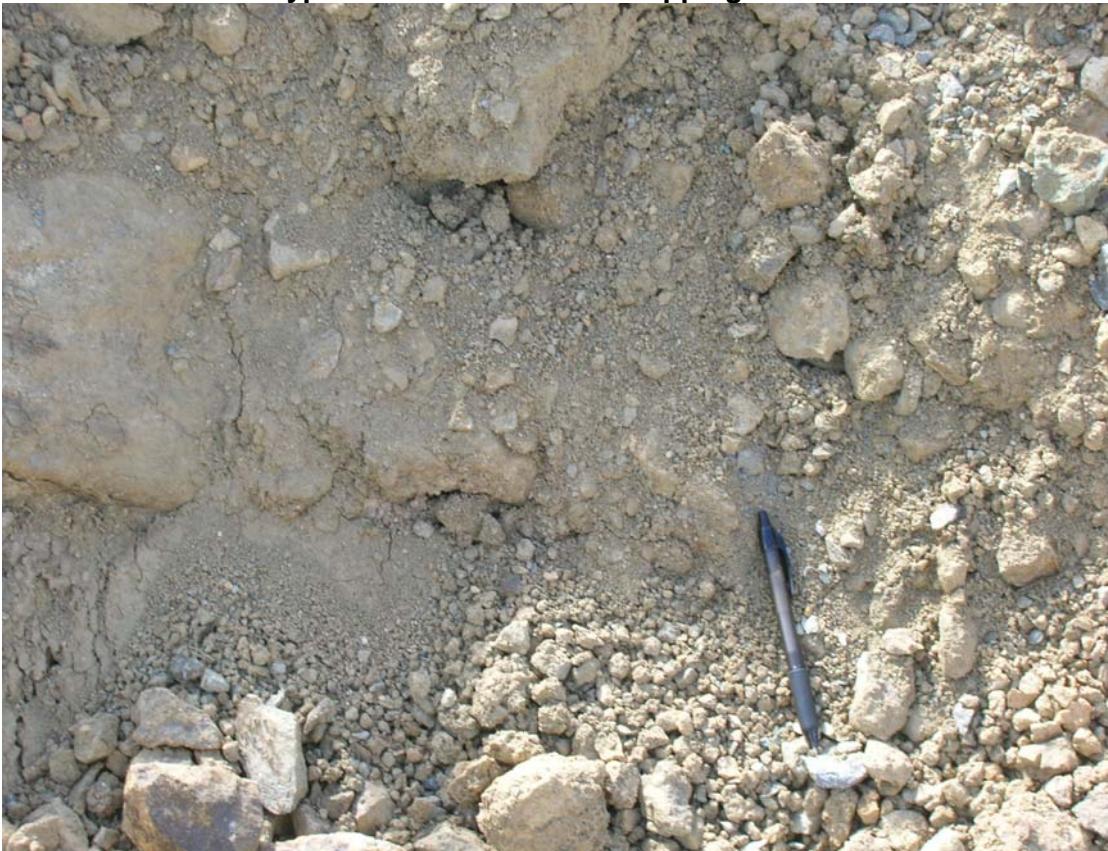
PHOTO 14 – High fines content of d/s rockfill

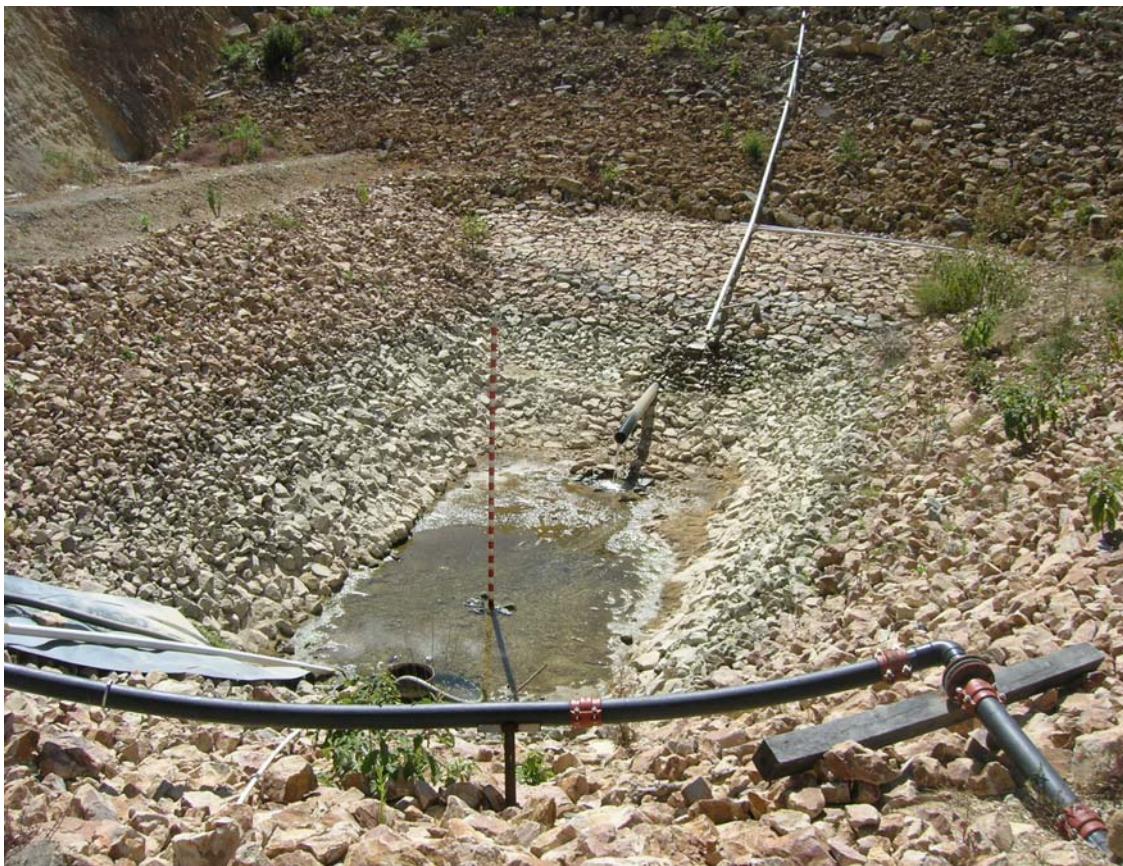
At the embankment toe seepage collection pond it was observed that drainage from the dam underdrain was very small (Photo 15) and it is apparent that the foundation grout curtain and dam core are effective in controlling seepage. Seepage flow through the V notch weir downstream from the dam was observed to be very small (Photo 17).

PHOTO 15 – Seepage return pond showing low drainage rate from dam drain system

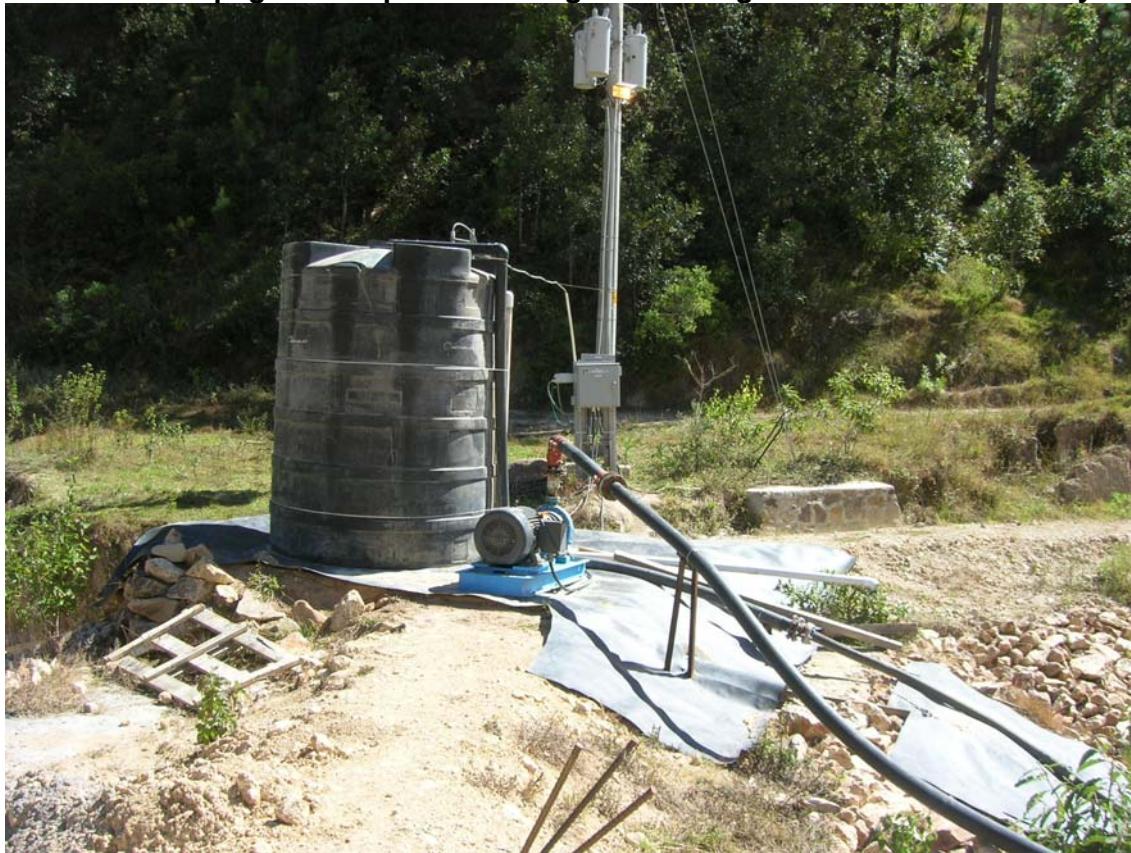
There has been a design change to return pond pumping system (Photo 16). The writer questions if the reliability the installed system and of standby capacity is sufficient for high precipitation events.

PHOTO 16 – New seepage return pump system

The seepage return pumpback system had been relocated from its original position near the downstream cut-off to pump directly from the seepage collection sump (Photo 16). *This pumping system should be upgraded to a permanent facility.*

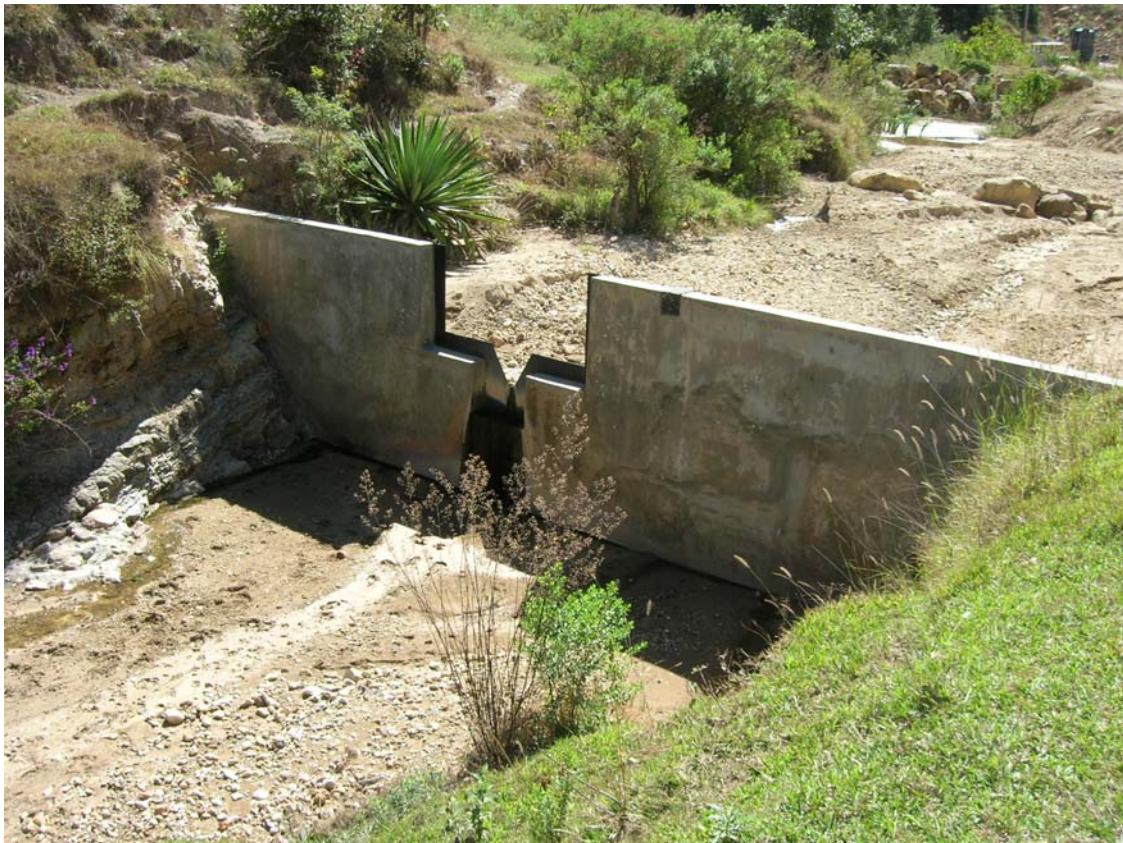
PHOTO 17 – Very low flow through V notch weir at d/s cut-off wall

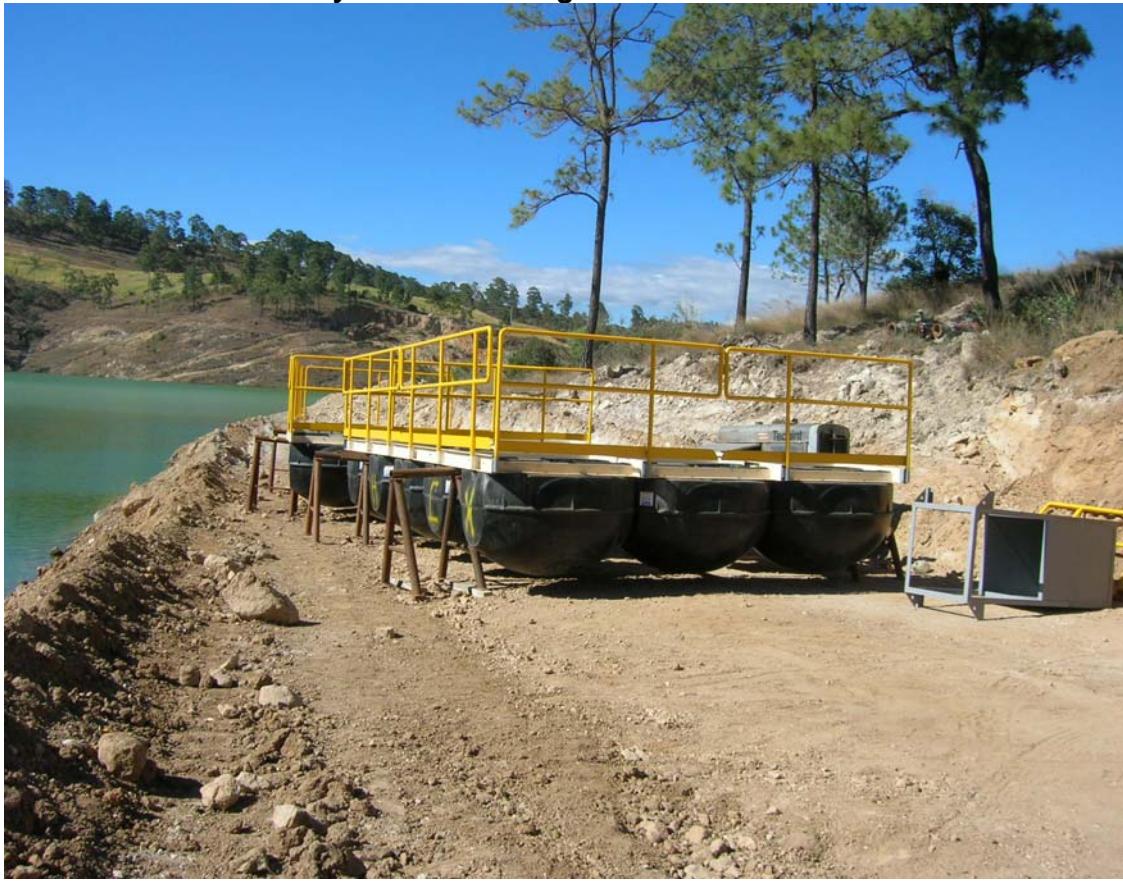
PHOTO 18 – Barge for replacement tailings water reclaim system

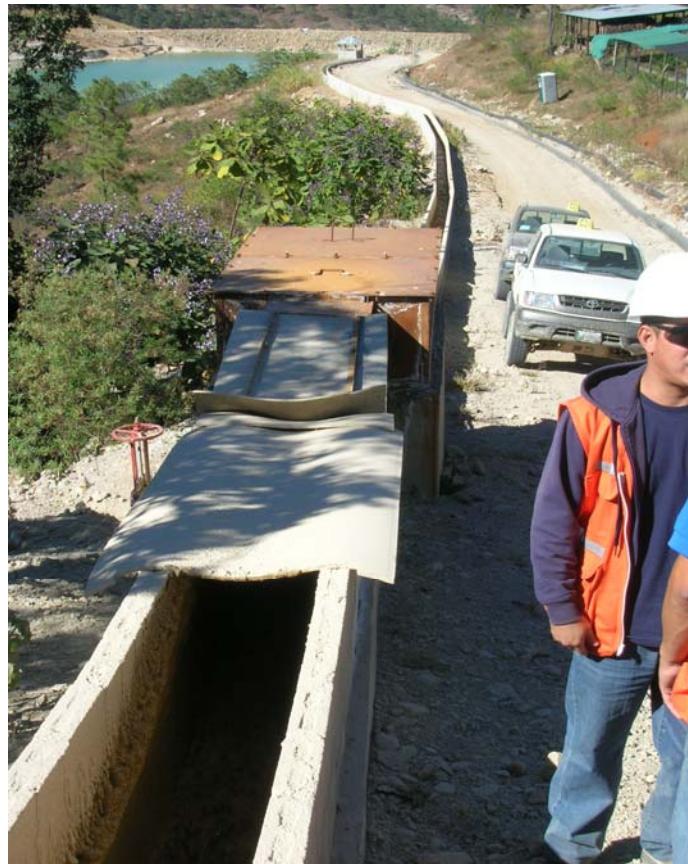
During inspection of the tailings flume it was seen that the flume wall height had been increased and modifications made at drop box's (Photo 19) to prevent spillage. Additional modifications were in progress to ensure the adequate function of this flume. It is noted that any spillage from this flume drains into the impoundment.

PHOTO 19 – Tailings flume with raised side walls and improved drop boxes

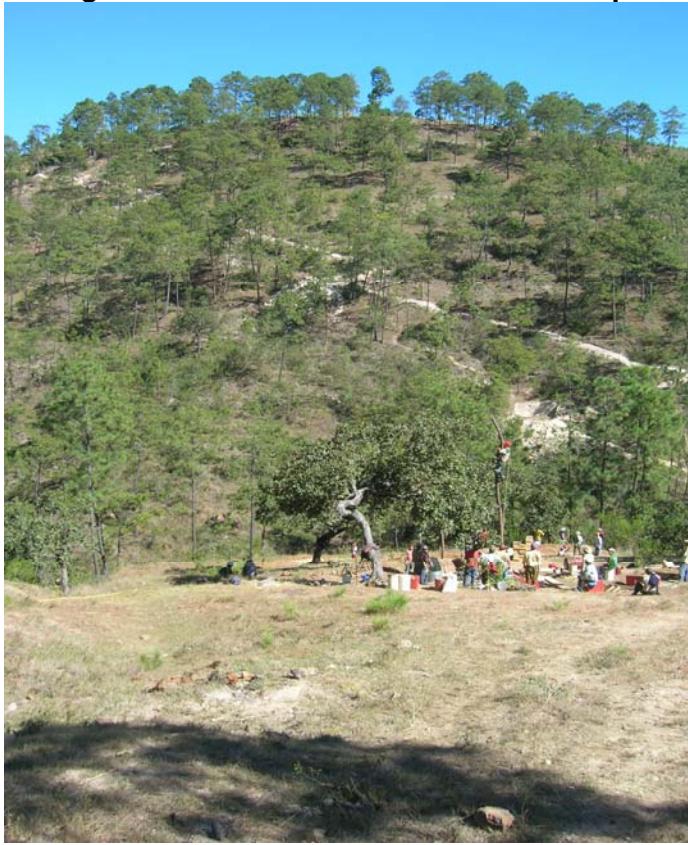
The proposed location for the water dam, in the valley adjacent to the right flank of the TSF, was inspected and the geotechnical investigation foundation drill that was in progress noted. An inspection of the creek bed at the centerline location (Photo 21) revealed the presence of shallow bedrock.

PHOTO 20 – Geotechnical investigation drill on proposed water dam centerline

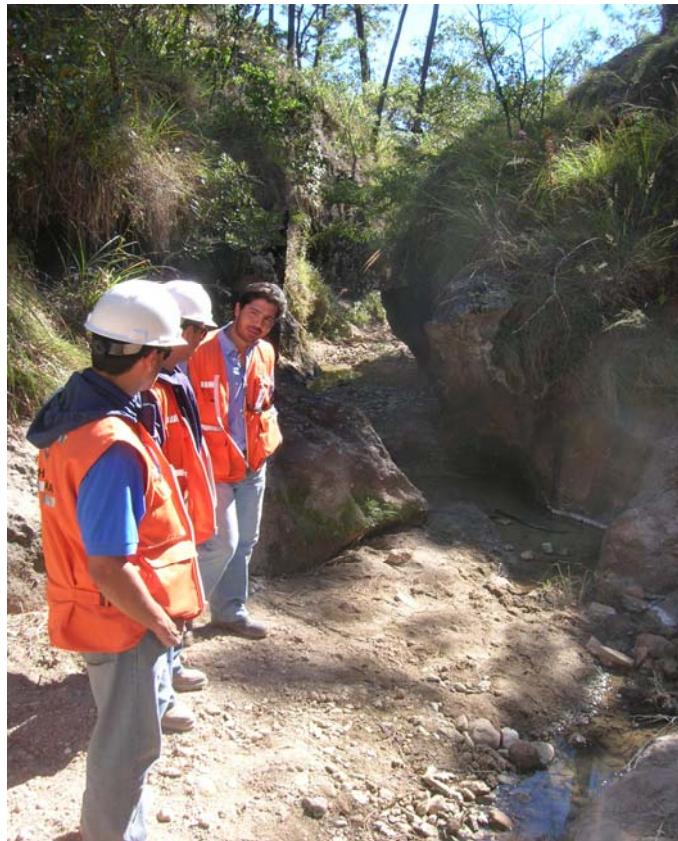
PHOTO 21 – Bedrock exposed in stream on water dam centerline

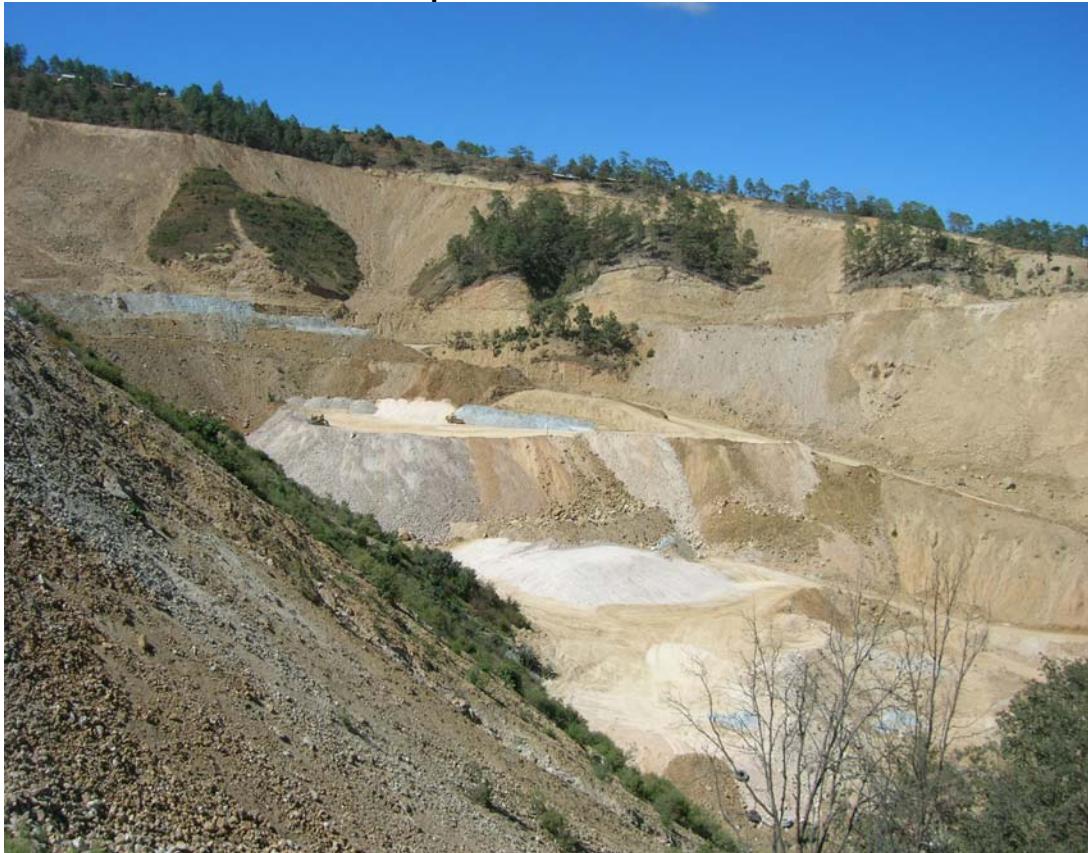
Inspection of the WRF indicated that the base drain had been constructed (Photo 23) and the WRD was being constructed in lifts (Photo 22). MEG is to be commended for the advances made since the last review meeting. Development was achieved under difficult access and production conditions, and is now effectively implemented.

MEG are to be commended for the improvement in dump development. The base drain (Photo 23) is in place. The dump is being constructed in benches (Photo 22).

PHOTO 22 – Waste Rock Facility (WRF) being developed in benches from bottom up
