- RGC REPORT NO 111001/7

DAM INSPECTION – December 2007

• TAILINGS DAM REVIEW BOARD REPORT NO 7

• MARLIN PROJECT, GUATEMALA

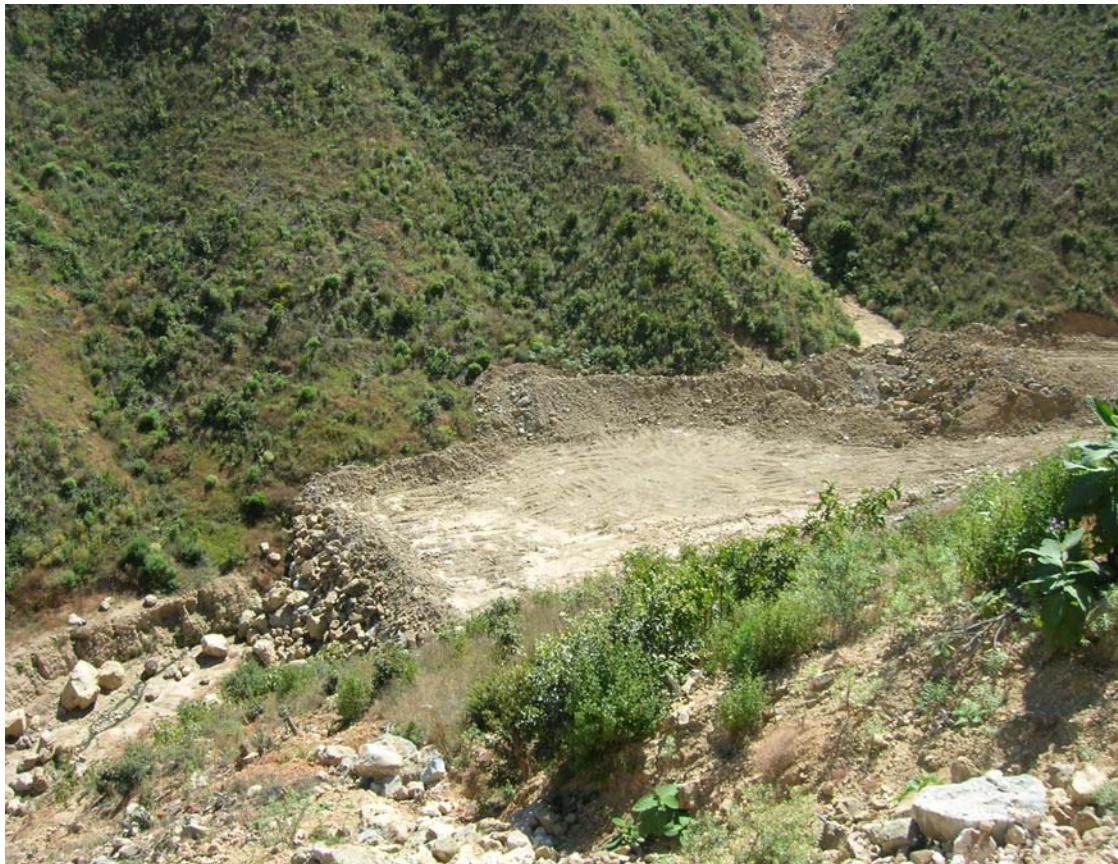
Inspection of the WRF indicated that the base drain had been constructed (Photo 23) and the WRD was being constructed in lifts (Photo 22). MEG is to be commended for the advances made since the last review meeting. Development was achieved under difficult access and production conditions, and is now effectively implemented.

MEG are to be commended for the improvement in dump development. The base drain (Photo 23) is in place. The dump is being constructed in benches (Photo 22).

PHOTO 23 – Toe drain for WRF

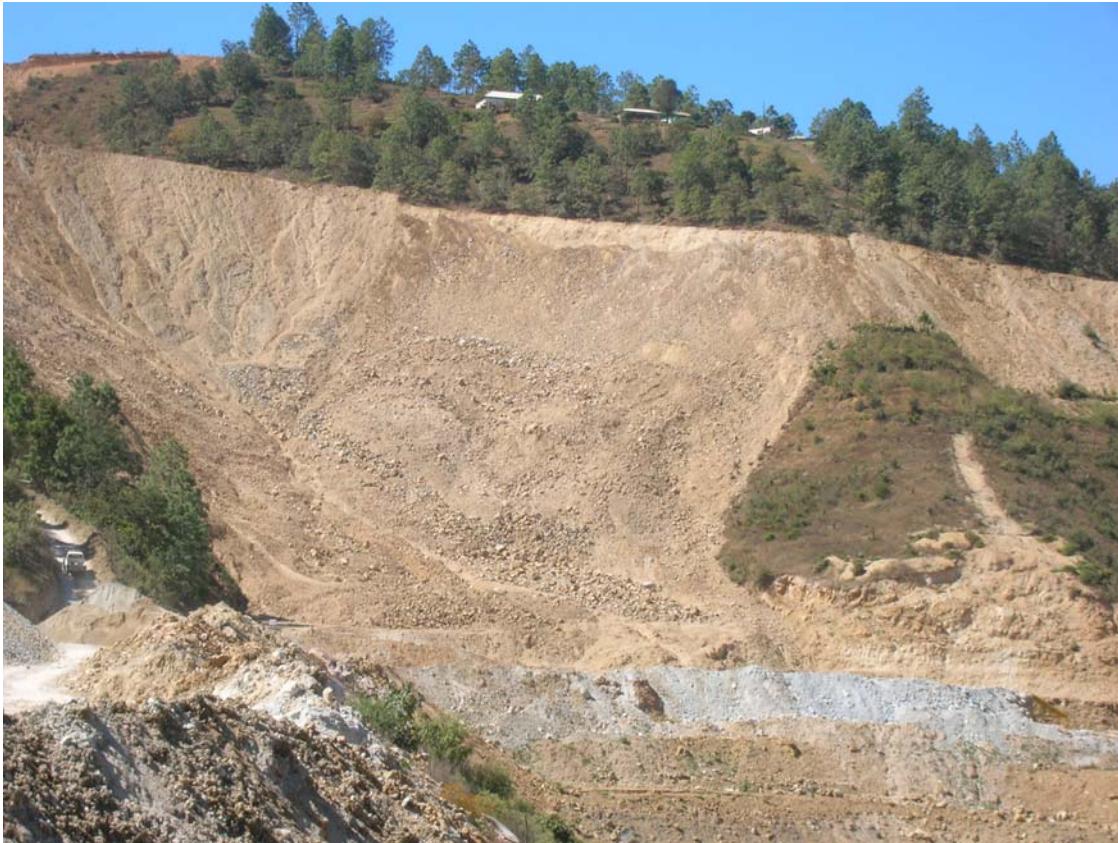
Older side slope waste deposits appear in many locations to be marginally stable with some shallow slumps and deformation flows occurring (see Photo 24). MEG are controlling impacts of such slumps with toe berms and slumped material removal. Further slumping can be anticipated and this poses a hazard to traffic on roads located below such dumps, particularly during the wet season. *It is recommended that a detailed stability evaluation be made of all these side hill waste rock fills to ensure that they meet acceptable stability criteria and that adequate drainage is provided to prevent pore water pressure induced failures.*

A slump of upper dump has been experienced (Photo 24) and no further dumping or toe excavation will be made without an engineering assessment.

Photo 24 – Slump of waste rock slope on upper bench

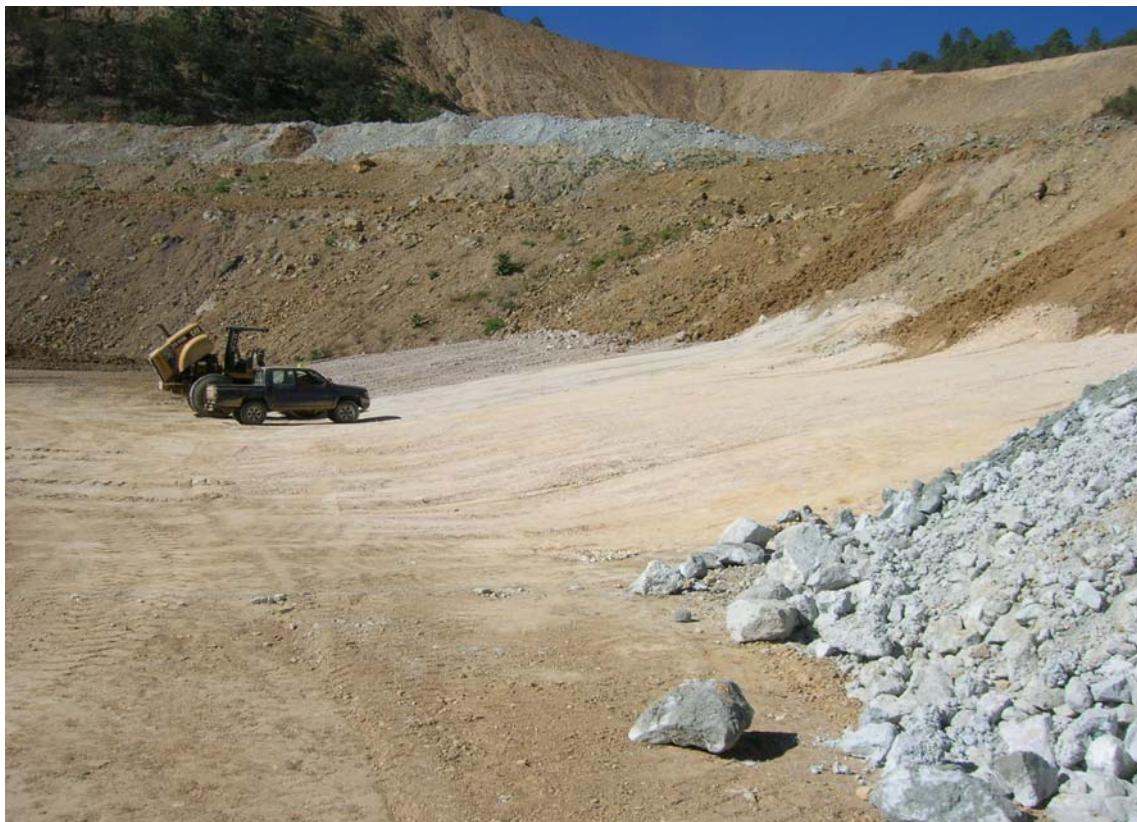
The placement of acid generating waste rock in cells with clay encapsulation was observed (Photo's 25, 26 and 22). The clay cover was being compacted. While some cracking of the clay covers were observed (Photo 26) it is expected that under the dump pressures and moisture conditions such cracking will 'heal'.

The placement of acid generating waste in cells and covering with compacted clay layers was observed (Photos 25 and 26). Modest cracking in the clay cover is expected to heal under the load and moisture conditions that will develop in the WRF. The encapsulation work is considered to be excellent.

PHOTO 25 – Zone of clay covered acid generating waste rock

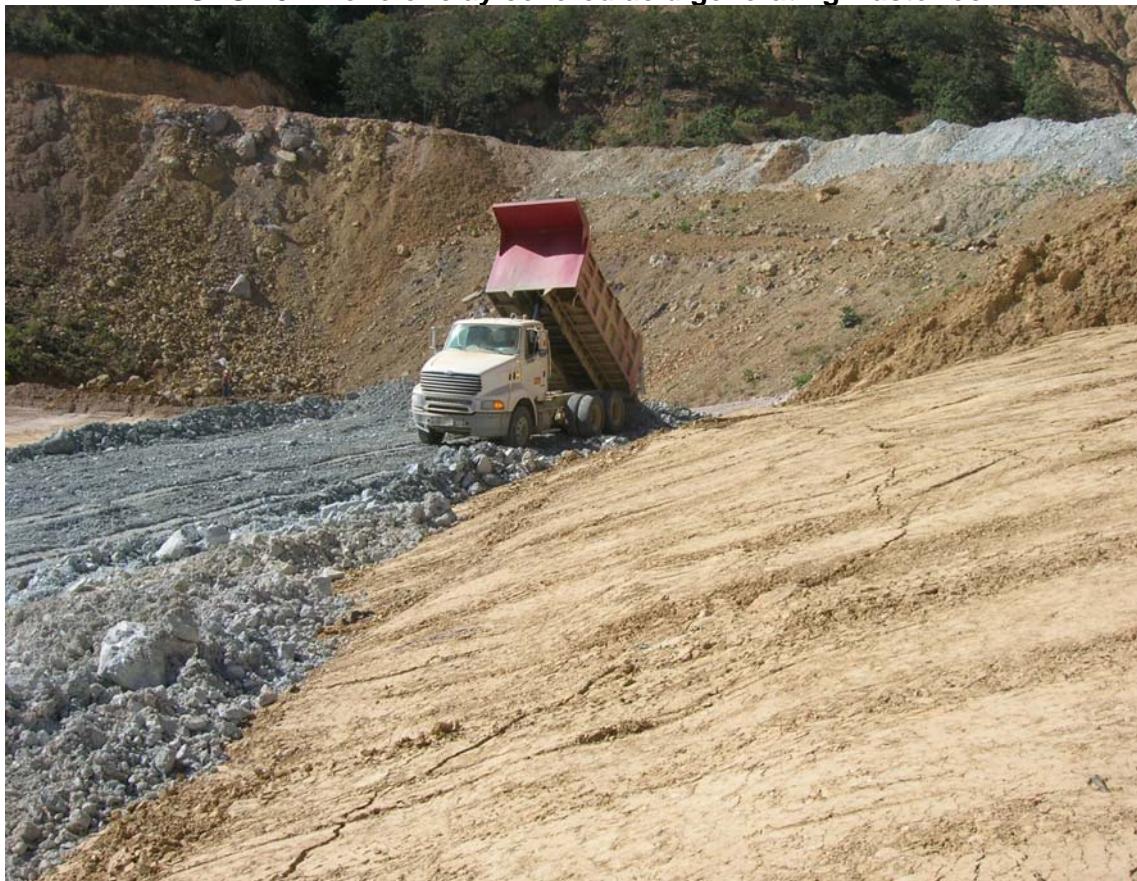
PHOTO 26 – Additional layer of ARD rock being placed. Note cracking of clay cover

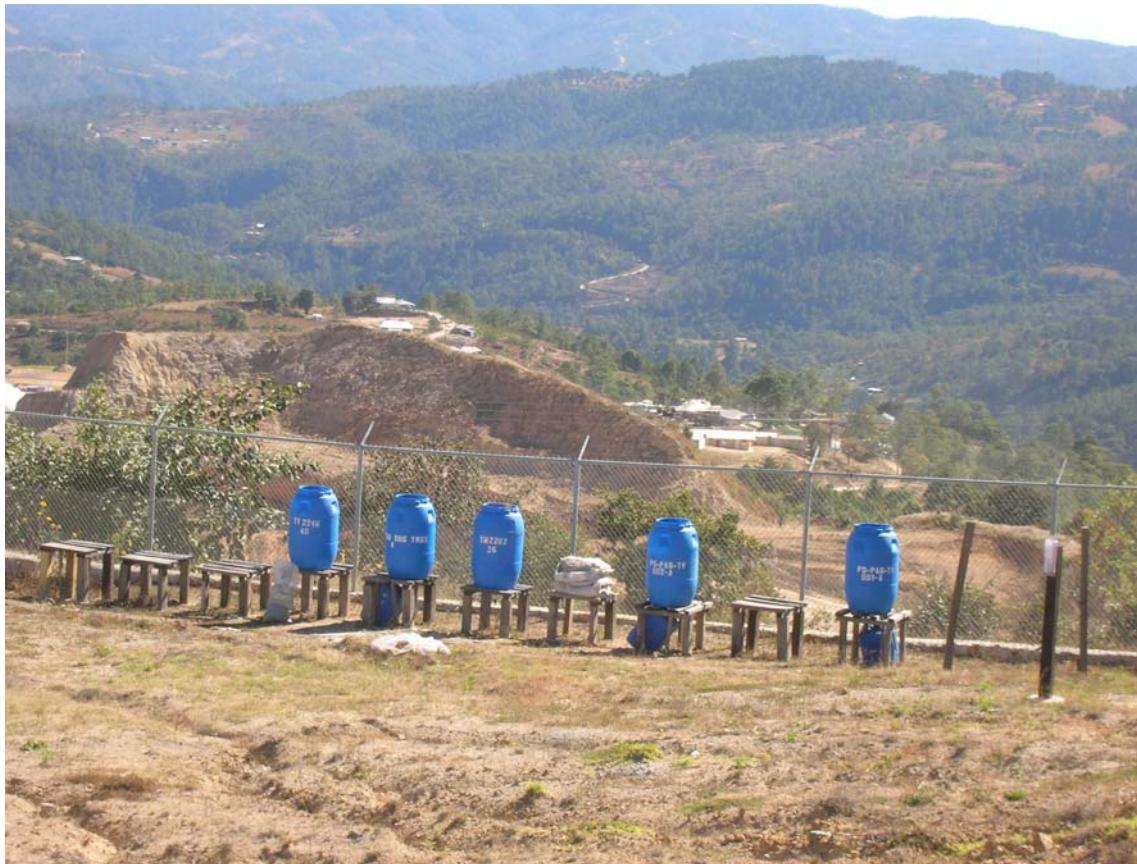
The site of the ARD field cells was visited (Photo 27) and it was noted that while cells are appropriately constructed, there was only a very small test program. *It is recommended that this program be expanded to better understand and characterize the waste ARD characteristics for this mine.*

Photo 27 – ARD of field cell (barrel) ARD testing.
