ROBERTSON GEOCONSULTANTS INC.

RGC REPORT NO 111001/9

DAM INSPECTION – November 2009 TAILINGS DAM REVIEW BOARD REPORT NO 9 MARLIN PROJECT, GUATEMALA

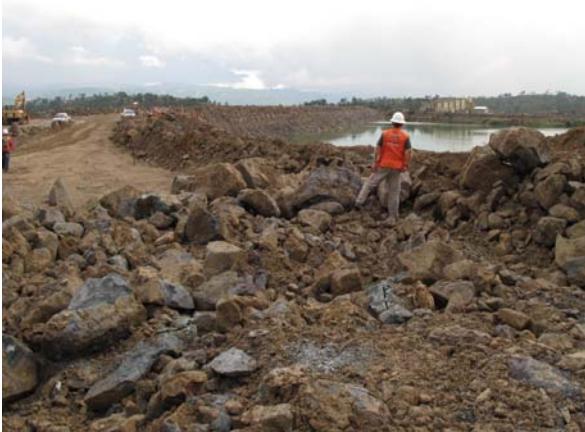
Tailings Dam crest at 1962 m, pond at 1949 m

The tailings dam crest elevation is approaching the final crest elevation of EL1962 m (see Photo 1). The tailings pond water was at El 1949. The dam impoundment is expected to be filled by mid 2011.

The rockfill being placed on 9th November had excessive fines (Photo 1). MWH report that the excessive fines fill was permitted only because placement was near dam crest in the freeboard zone of dam. Rockfill placed on 10th November was of good quality and grading. The Marlin pit was visited to inspect the rockfill source (Photo 17). The weathering and rock strength characteristics of the mined rock changes rapidly over short distances. The difficulty of selectively mining good quality rock is apparent (Photo 18). The underground has priority for good quality rock which is used for underground mine backfill. The consequence of the poor quality rockfill in the tailings dam are increased settlement and a need for long term monitoring and maintenance. The stability of the dam is not in question.

The tailings pond was observed to contain an excessive amount of water (Photos 1 and 21). With the excessive water volume there was only a modest area of 'beach above water' on which tailings segregation and drying can occur. As a consequence almost the entire tailings deposit in the TSF has been deposited as 'beach below water' with a low density. One of the consequences is a reduced average tailings density. This reduces the storage volume of the impoundment and increases the post closure settlement that can be expected.

The rockfill observed being placed on November 9 appeared to have excessive fines (see Photo 1). It was explained to the writer that such high fines rockfill was being tolerated because it was the last half meter of dam rockfill placement. The rockfill observed placed on the 10th November appeared to be consistent with the specified grading.

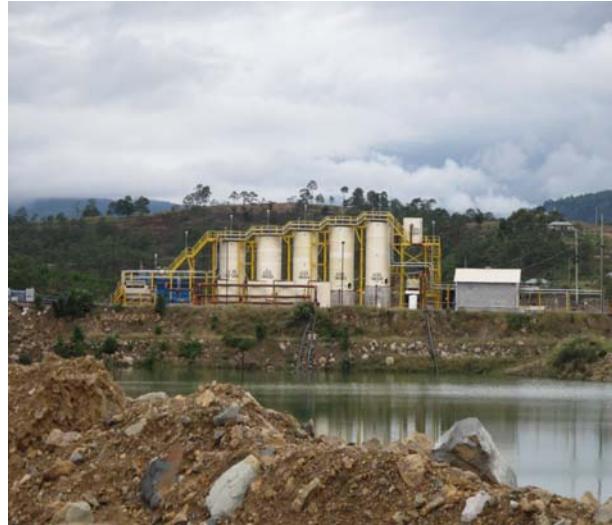
Water treatment plant operational

The water treatment plant has been constructed and is operational (Photo 15), however it is due to be moved to higher ground to allow the completion of the East Saddle dam. The water evaporators were functioning during the inspection (Photo 14).
